Final Interim Report – Task 1.4

Battelle's Experience with ERW and Flash Weld Seam Failures: Causes and Implications

B. N. Leis
and
J. B. Nestleroth

Contract No. DTPH56-11-T-000003
Battelle Project No. G006084

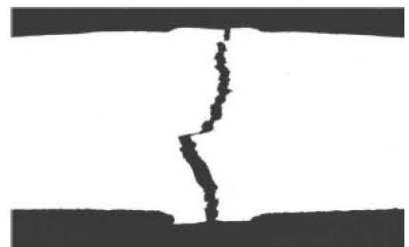
c) OD Origin: complex crack path tracking planes of inclusions
LFERW with $t = 0.375$ "

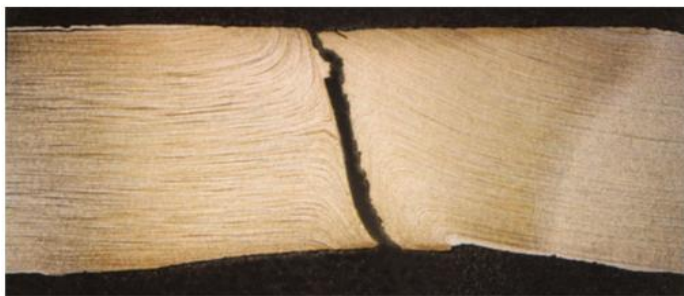
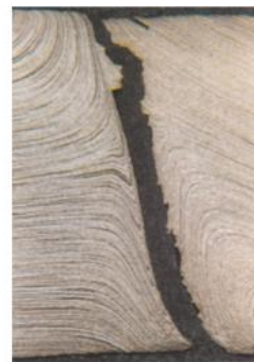
The cross section in Figure 8a shows etched views of LFERW that had a nominally 0.250-inch thick wall, where the effects of offset edges combined with the upset force to produce a skewed weld where the ID scarf caused wall-thickness reduction adjacent to the seam over most of the length of the joint that initiated rupture in a hydrotest. The seam is skewed the order of 12° from perpendicular, and is associated with ~11% reduction in the pipe wall due to the ID scarf, which was trimmed neat to the wall on the right side of the seam, but cut well into the offset wall on the other side of this seam, and into the OD surface. The extent of the over-scarf in this case was compounded by an in-tolerance but less than nominal thickness pipe wall.

a) slight ID/OD over-scarf in a seam skewed due to edge offset

b) detail in a)

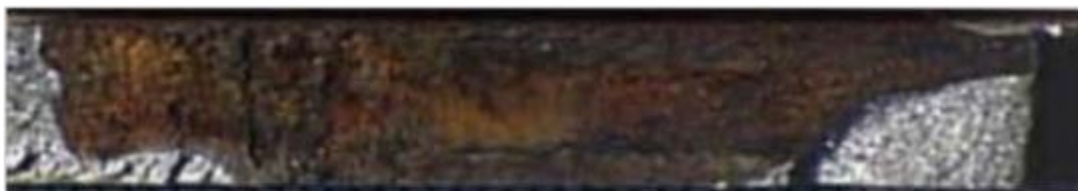
the pre-service test. Overall it appears as a single defect, with a length of $\sim 2\frac{3}{8}$ inches, while its maximum depth appears to run through the full wall. Characterizing this from a fracture mechanics perspective might idealize it as a TW defect coupled with a rectangular area-based equivalent length somewhat under 2 inches, while for plastic collapse analysis it could be represented in terms of its net-section area. However, whether either is relevant can depend on details hidden by the oxide, and as well as the ability of existing models to quantify such response absent knowledge of the strength across the interface and its toughness.

Figure 17. Fracture surface, as opened: HFERW with $t = 0.219$ " and OD surface up

Cross sections made through the reconstructed fracture after capturing all needed images of the intact surface show that the failure occurred fully within the bondline of the weld. Transverse cross sections made through rings of pipe that lay just beyond the ends of the excised coupon showed that the bondline was free of through or part-through thickness defects, and otherwise sound. Etched views of those sections were typical of modern HFERW – although the HAZ appeared rather broad. These views showed scattered ferrite in the bondline, and the presence of some center-line segregation that did not contribute directly to this failure. While the weld was slightly over-scarf'd, this was minor and well within the wall tolerance.

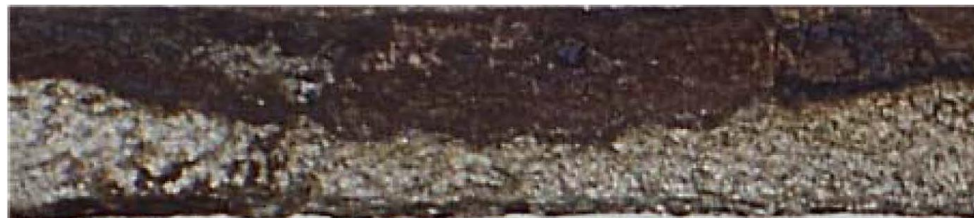
Figure 21. Fracture surface illustrate crack-like features formed via SSC: LFERW

adjacent grooving, as evident for example in Figure 6a versus Figure 19a. In addition to failure through the root of the V-groove, or through the axial coalescence of adjacent V-grooves, SSC can lead to very localized narrow attack that can develop deep into the pipe wall from the root of the V-groove, creating crack-like features that pose a much greater integrity threat than the V-groove alone. Figure 10 showed a fracture surface that was illustrative of such localized attack into the pipe wall, which is further discussed next in regard to Figure 21.
